# Temperature fluctuations in down-fired reformer furnaces

**DAN BARNETT, JOE PRICE**

**BD Energy Systems, LLC**

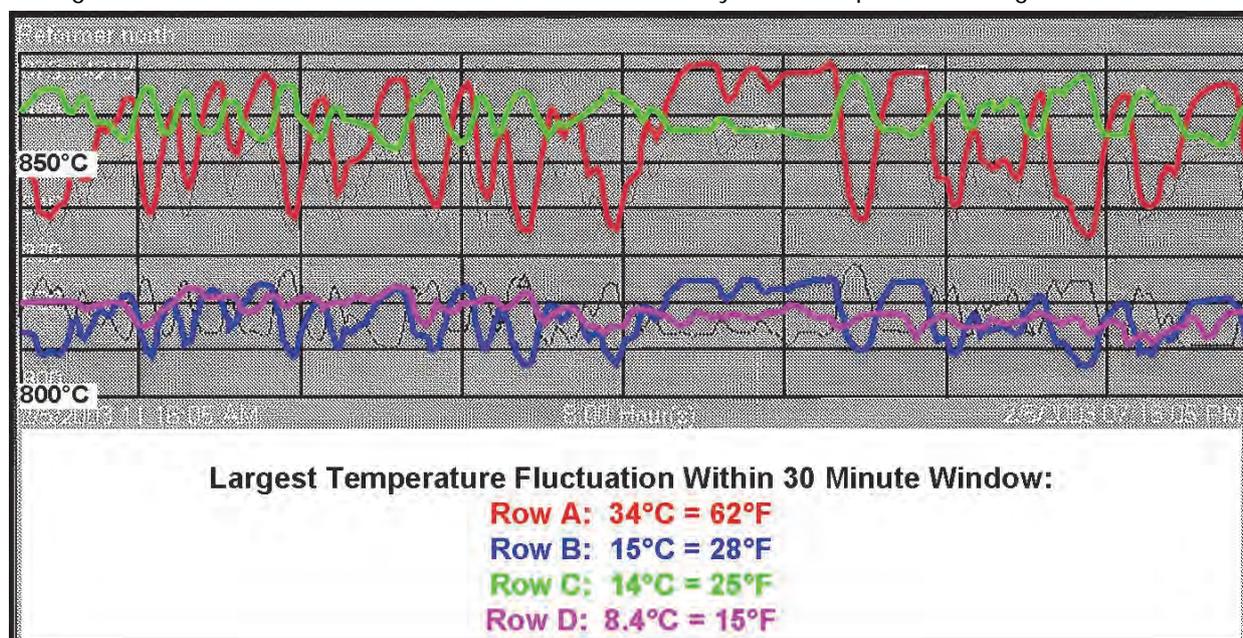
**Fig. 1: Process Outlet Temperature Fluctuations in a Methanol Reformer**

Figure 1 shows the temperature fluctuations experienced in a large methanol reformer over a period of eight hours. It can be seen that the largest fluctuations occurred in Row A followed by Row B which is located next to Row A. Rows C and D are located three and seven rows, respectively, away from Row A and on the opposite side of Row A than Row B. Row D is relatively constant by comparison to the other three rows but this figure illustrates that several rows of tubes are affected by these temperature swings.

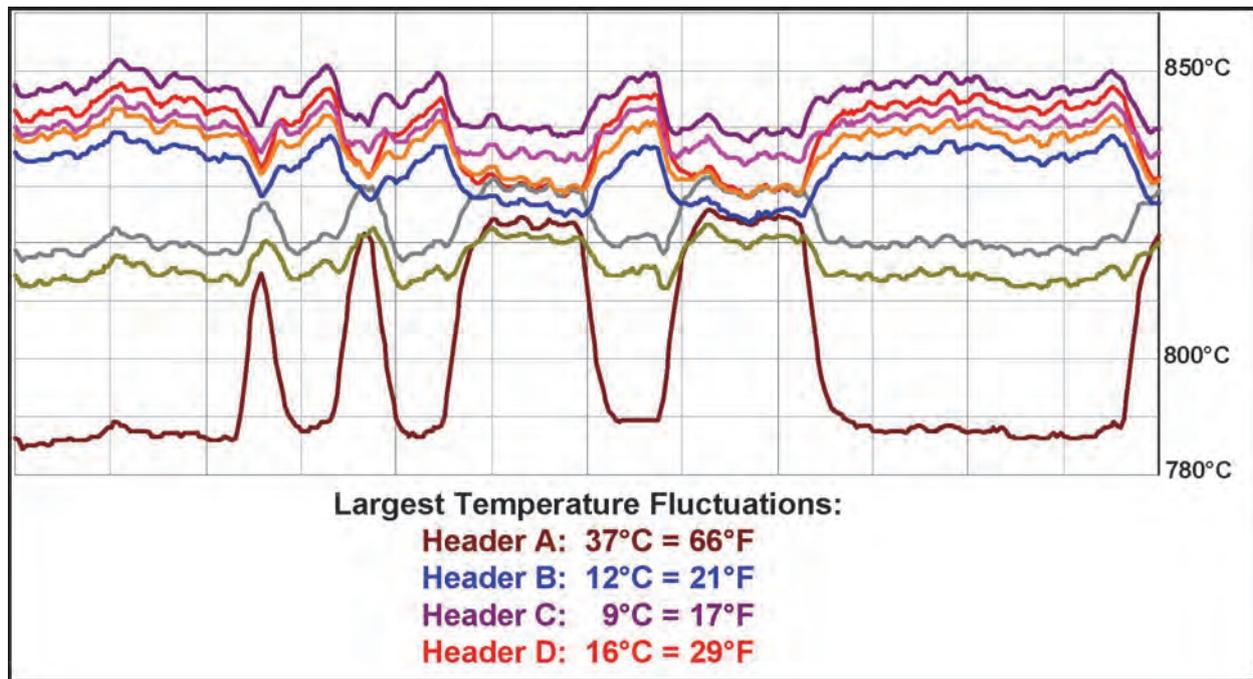
**Fig. 2: Process Outlet Temperature Fluctuations in a Hydrogen Reformer**

Figure 2 is another illustration of this behaviour. This figure shows the temperature fluctuations in a moderately sized hydrogen reformer over a period of six hours. The largest temperature swings can be plainly seen in Header A. It is also apparent that when the swings occur, that the entire furnace is affected to varying degrees as evidenced by the corresponding temperature fluctuations in the remaining headers. Header B has the next highest change in temperature and is located four rows from Header A while Headers C and D are located two and three rows, respectively, from Header A.

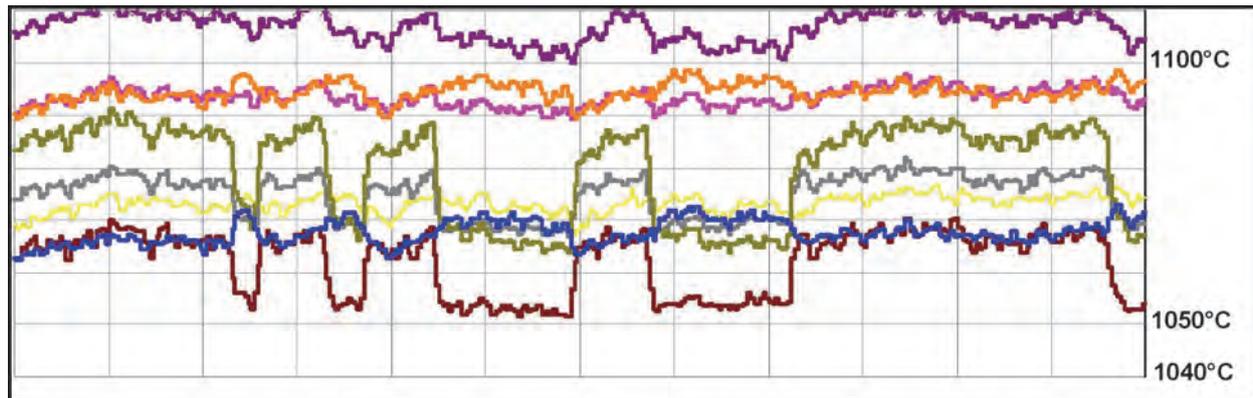
**Fig. 3: Tunnel Flue Gas Outlet Temperatures Corresponding to Figure 2**

Figure 3 is a plot of the tunnel exit flue gas temperatures that correspond to Figure 2. Though all of the trends do not show correspondingly large swings in flue gas temperature, the temperature of those tunnels that do react generally moves in the opposite direction of the process temperature swing.

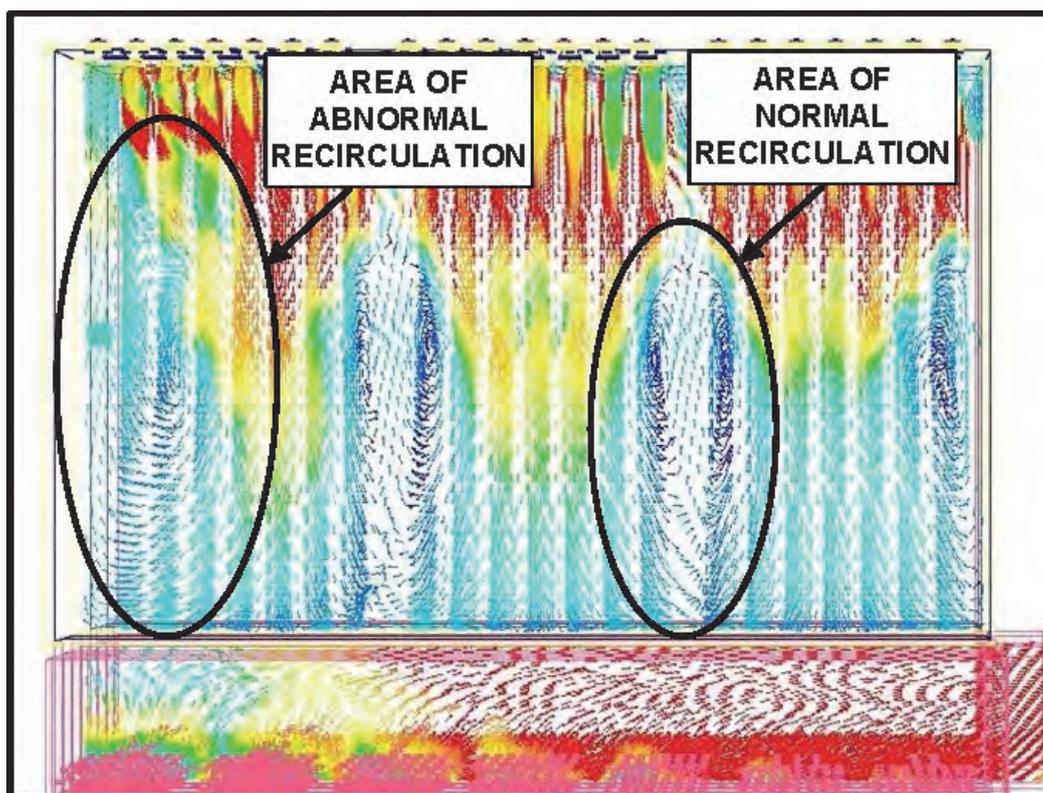
**Fig. 4: Flue Gas recirculation Patterns**

Figure 4 illustrates two flue gas recirculation regions with one region indicating normal recirculation while the second region shows an abnormal recirculation pattern.

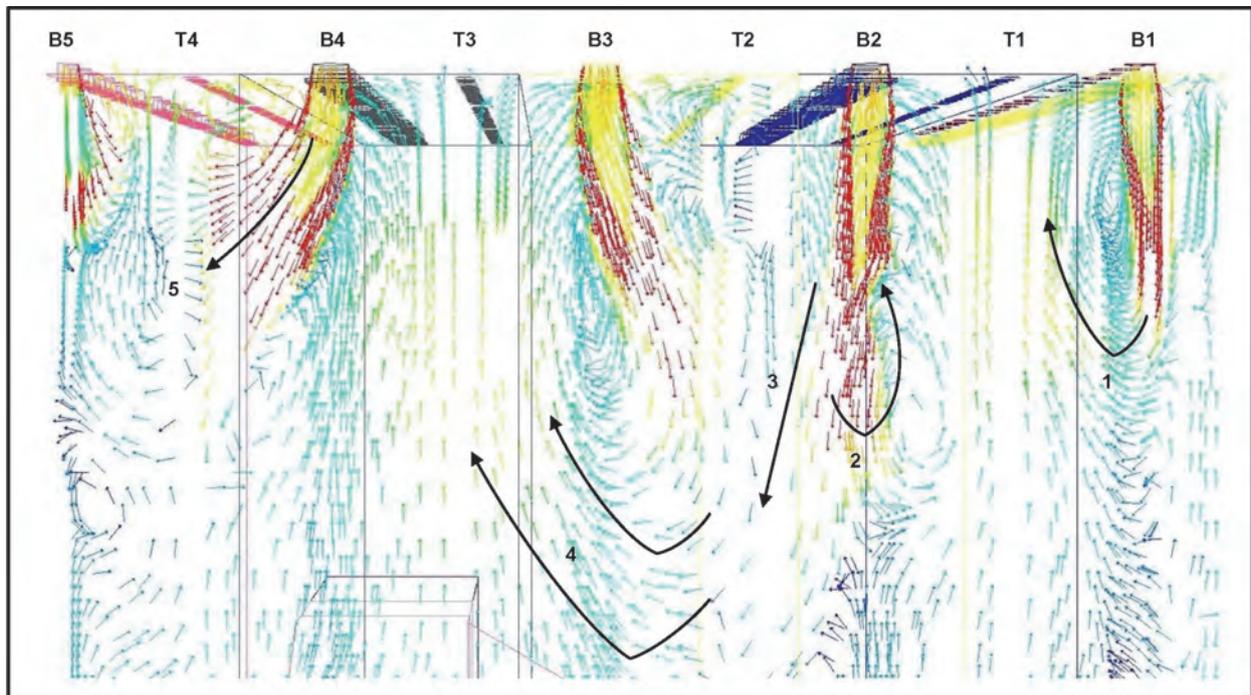
Fig. 5: Development of Abnormally Large Flue Gas Flow Pattern

As the recirculation pattern from row B1 develops, it reduces the amount of space between rows B1 and B2 for the row B2 burners to recirculate properly and basically “pushes” the row B2 flame towards catalyst tube row T2.

As burner row B2 is pushed toward catalyst tube row T2, it causes a change of direction in the momentum of burner row B2 (point 3) towards burner row B3 which pulls the flame pattern of burner row B3 toward burner row B2. Note that this effect would be minimized or overcome if the burners had a higher magnitude in momentum resulting in a stiffer flame.

The result of burner row B3 bending toward catalyst tube row T2 is that the momentum effect on burner row B4 is minimized and the flame of burner row B4 is now pulled toward burner row B5 because there is no counter-effect from burner row B3 (Point 5). This creates a very large recirculation zone between burner rows B3 and B4 (Point 4) which exacerbates the bending of burner rows B3 and B4. These effects can be further understood by noting:

- There is virtually no upflow between burner rows B2 and B3. The velocity vectors indicate all downflow at this location
- There is virtually no downflow between burner rows B3 and B4. The velocity vectors in this region indicate all upflow.

This large recirculation zone is the same region where the catalyst tubes experienced the highest temperature fluctuations and where the catalyst tubes experienced noticeably higher creep damage and where the catalyst tube failures occurred.

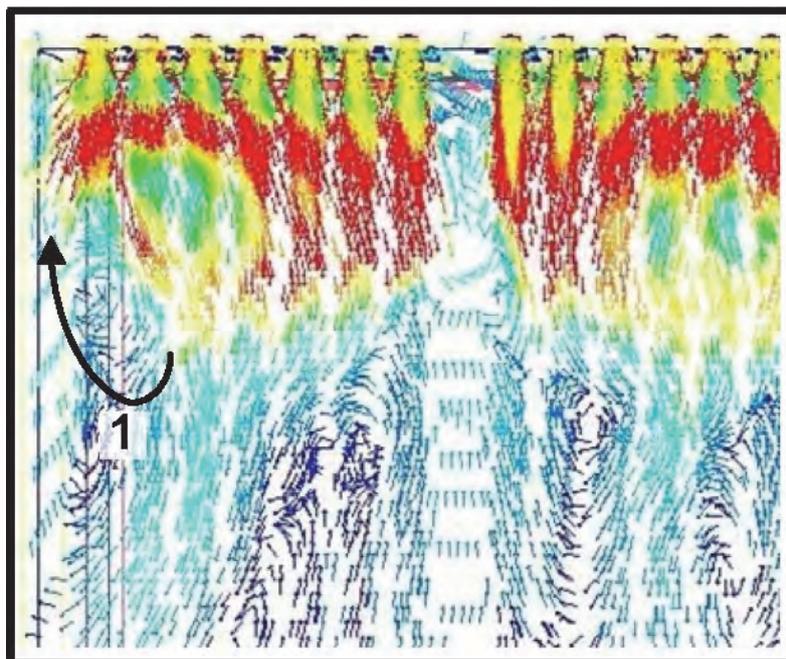
Fig. 6: Recirculation Pattern in Burner Row Plane

A difference in burner momentum between burner rows can be the result of an imbalance of combustion air but is more often cause by designing the outside row burners to fire at a lower rate, usually 60% to 70% of the inside row burners. While this design practice is highly recommended, there are instances where the downsized burners were not designed to deliver the same momentum as the full size burners. Because of this lower momentum, the burner flame rigidity is low and a recirculation pattern develops early in relation to the downward flow of the flue gas. This can be seen at Point 1 in Figure 5 in burner row B1. This recirculation pattern also causes the flame to lean toward the catalyst tube row T1. Figure 6 reveals that this recirculation also occurs in the plane of the burner row which increase the volume of the recirculation zone.
