Reformer Furnace Outlet Systems

Design Considerations, Emergency Repair, and Enhanced Reliability

[First published in "Nitrogen+Syngas" Number 324 - July/August 2013]

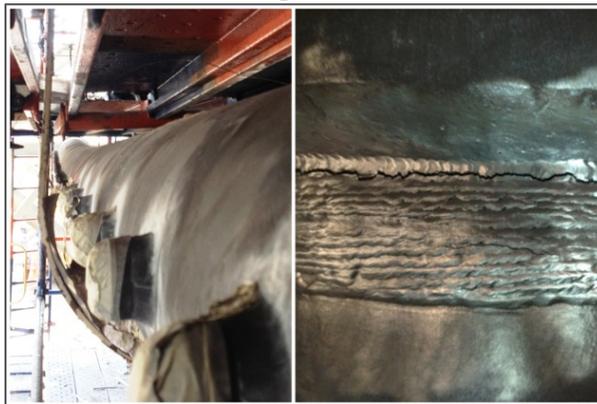
- Cracks and possible through-wall failures along the length of the manifold [most common at welds]
- Bowing or deformation of the manifold along the length [see Figure 5 photo]
 - Can be the result of water coming into the manifold from pigtail low points or accumulating in a sagged manifold following a shutdown
 - Can be caused by long-term under-support or over-support along the length of the manifold
 - Can be caused by restriction of thermal movement at one or more support points

- Cracks at the welds between the manifold and the tee or between the tee and the cone [see Figures 5&6 photos]
 - Can be caused by under-support or over-support of the manifold weight causing high stress at the weld connection to the tee
 - Cracks in the weld to the cone can be caused by asymmetrical under or over-support of the connecting manifolds to the tee
 - Above can be the result of restricted thermal movement at one or more of the support points

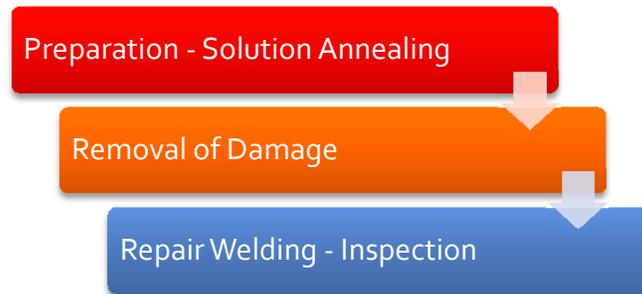
There are varied opinions regarding best practices for successful repair of reformer outlet systems. From the success stories found, it is apparent that the best practice depends strongly on the specific set of circumstances. Breaking the activities down to three basic steps is helpful when attempting to plan the best repair approach for each individual situation.

The potential benefits of solution annealing relate to addressing the issue of carbide precipitation and embrittlement of either 800HT or the cast equivalent 20Cr-32Ni material. It is well-established that service-exposed 800HT and cast equivalent 20Cr-32Ni materials are subject to severe loss of repairability due to susceptibility to heat affected zone cracking upon repair attempts. There are numerous references which conclude that high temperature solution annealing and relatively rapid cooling is necessary in order to redistribute carbides and other precipitates into the material and restore repairability. A number of reputable references [1, 2, 3] recommend that solution annealing be carried out at a temperature of 2100-2150°F for up to 6 hours (minimum 1 hour per inch of thickness) followed by rapid air cooling. This practice has been found to sufficiently disperse precipitated carbides and other precipitates back into the material allowing subsequent removal of damage and repair welding to be done with proper care. Rapid cooling with fan driven air prevents excessive re-precipitation of these compounds.

Removal of cracks and adjacent damaged areas in preparation for repair welding is done following solution annealing. The removal of through-wall cracks around a segment of a weld circumference may be best carried out using grinding and cutting methods that put relatively low heat into the adjacent area. Excessive heating of the material during this step can lead to propagation of cracks around the circumference or into adjacent material in a manner sometimes referred to as “spider cracking”. If the cracks do not extend through the entire thickness of a thick-walled manifold or tee, it is sometimes possible to use a small diameter electrode to arc-gouge into the material to get below the root of the crack for removal. The use of a small diameter electrode again limits the amount of heat input and the amount of material removed.

Repair welding is done after confirmation that all cracks are removed. In some cases, “buttering” of the repair area using small diameter weld consumables is often beneficial as a means to begin the fill of large or thick-wall repairs. Buttering can also help to put some distance between the main portion of the weld and the base material that may remain subject to liquation cracking problems. Again, low heat input is beneficial.
